Navajo Abandoned Uranium Mine

Site Screen Report

Mine Name: **Tom Klee**

Mine IDs: **73, 74**

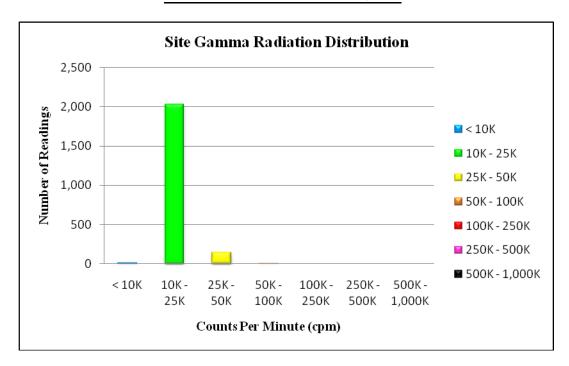
Highest gamma radiation measurement: 50,220 counts per minute (cpm)

A total of 2,186 gamma radiation measurements were collected from the mine site, ranging from 9,265 cpm to 50,220 cpm. Measurements collected in the vicinity of the reclamation area between sites 73 and 74 were found at a maximum level of approximately 35,000 cpm. The measurements are represented in Figures 1, 2, 3 and 4.

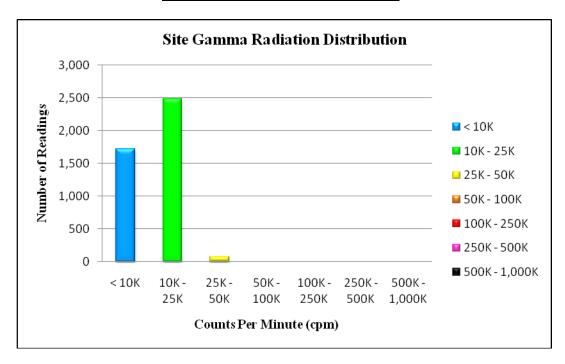
Highest gamma radiation measurement: 37,161 cpm

A total of 4,279 gamma radiation measurements were collected from the mine site, ranging from 5,565 cpm to 37,161 cpm. Measurements collected in the vicinity of the reclamation area between sites 73 and 74 were found at a maximum level of approximately 35,000 cpm. The measurements are represented in Figures 1, 2, 5 and 6.

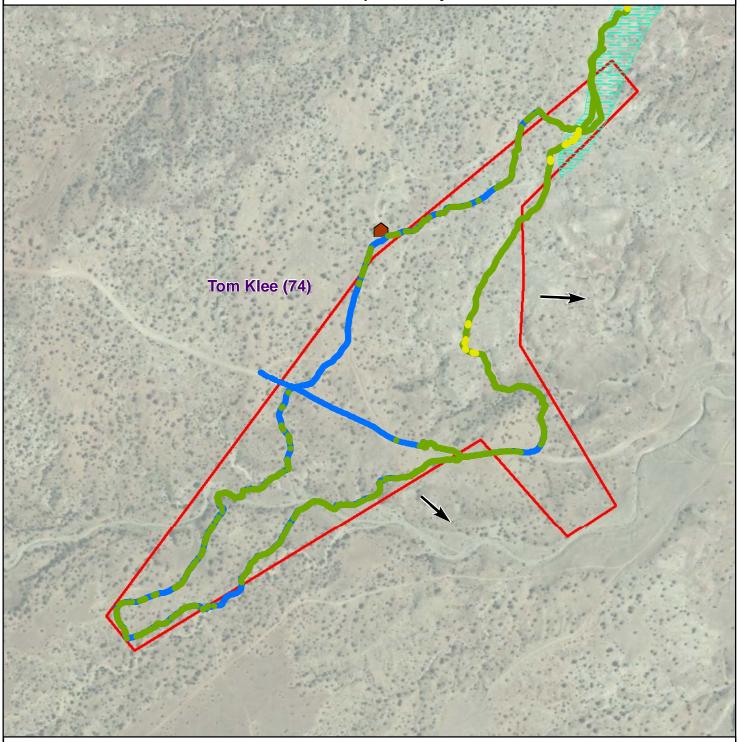
Figure 5 - Gamma Radiation Measurements, Above Two Times Background Tom Klee (74) Chilchinbito Chapter, Navajo Nation Tom Klee (74) Legend Mine Site Boundary **Gamma Radiation Measurements** General Slope Direction < 2X Backgound Feet 750 **Observed Reclamation Feature** > 2X Background Measured as counts per minute (cpm) Observed Waste Pile **Observed Structure** Average background 10,679 cpm Steep Grade
